Appendix B
Photograph Log and Photographs

Super Salvage, Inc.
Industrial Stormwater Inspection Report

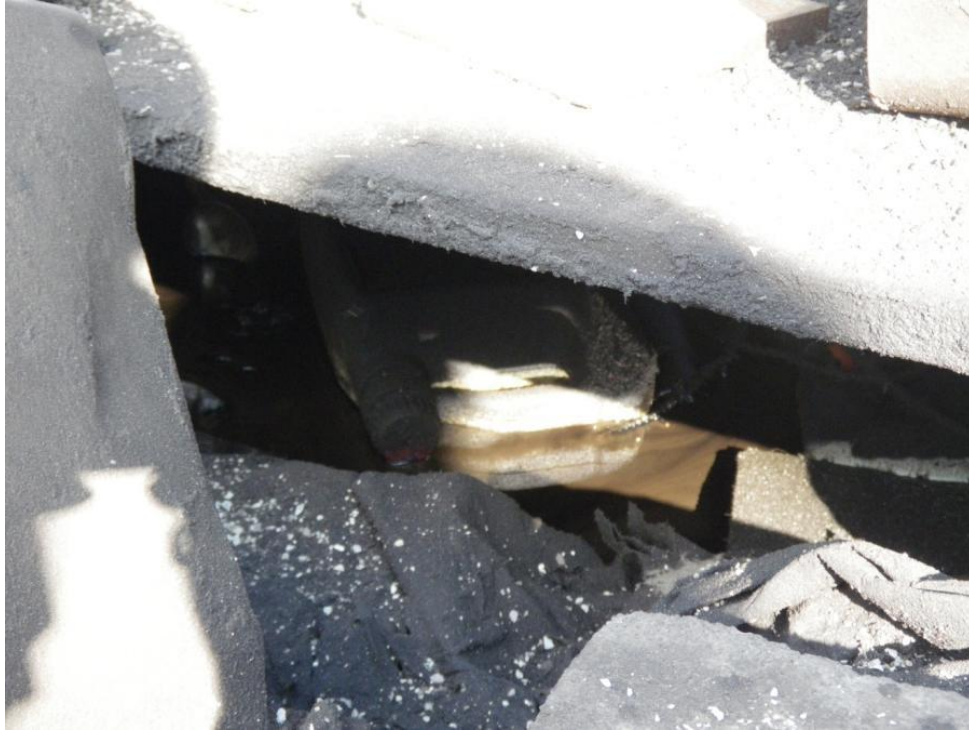
Photograph 67. Close-up view of what appears to be oil pooled under tanks near Entrance 1.

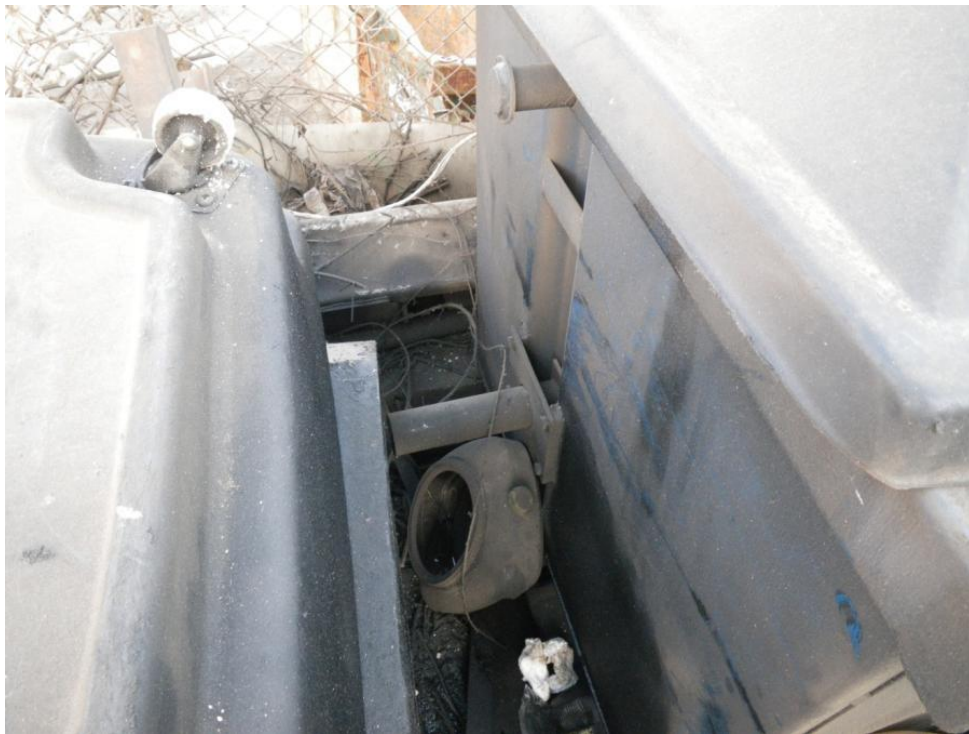
Photograph 72. Alternate view of container from Photograph 71 showing exterior staining.

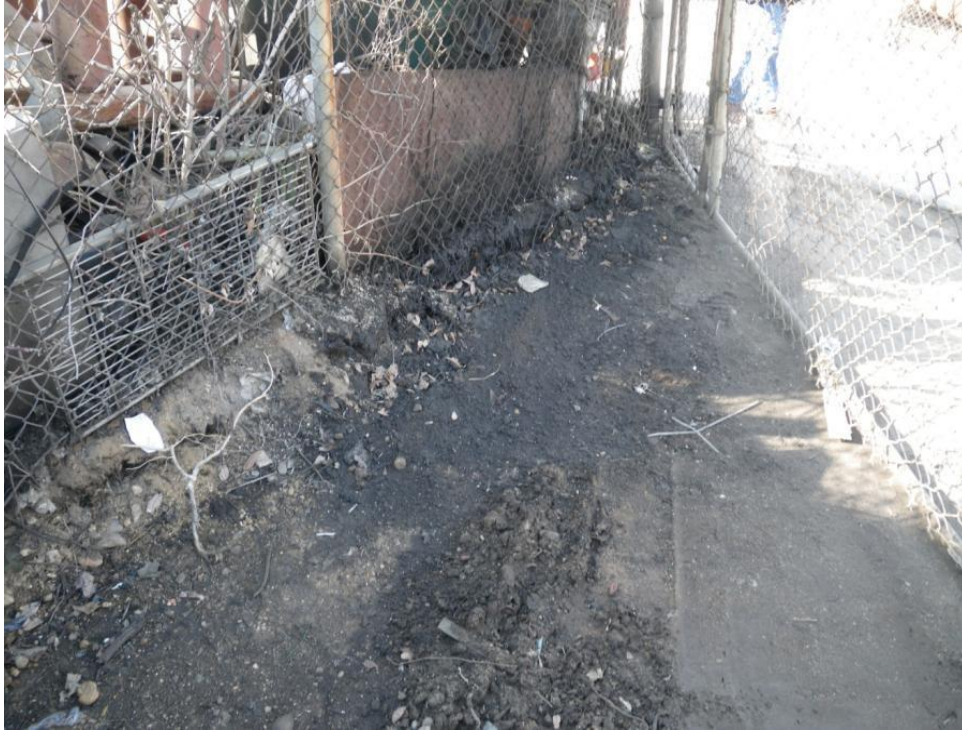
Photograph 73. View from the outside of the perimeter fence showing staining.

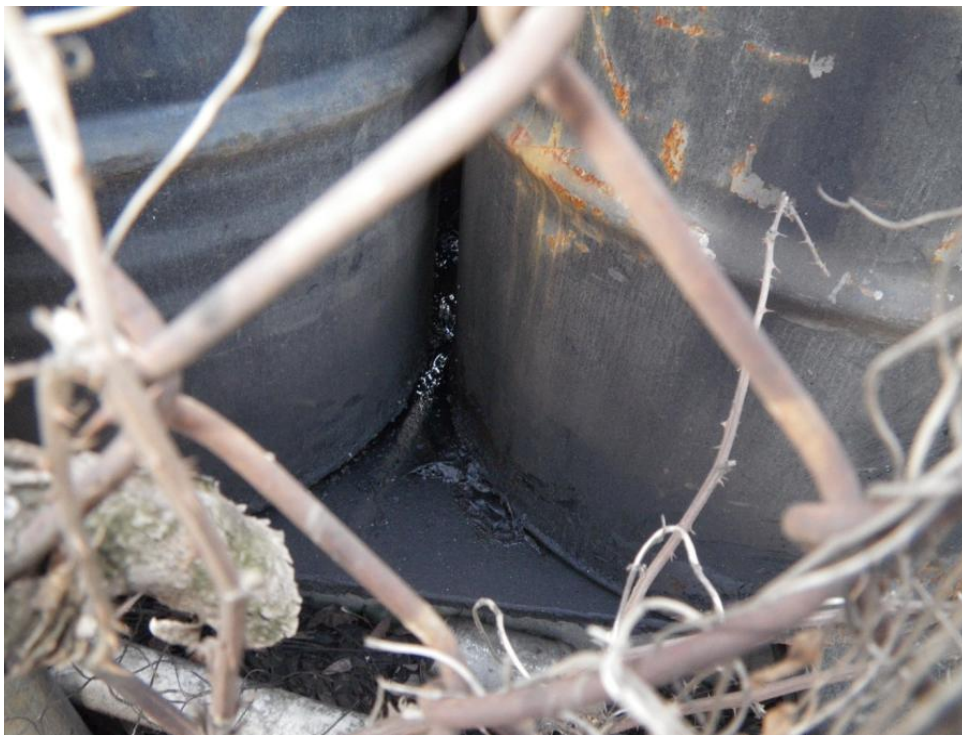
Photograph 74. Close-up view of two barrels containing used oil filters sitting on top of secondary containment. Containment is adjacent to the berm.

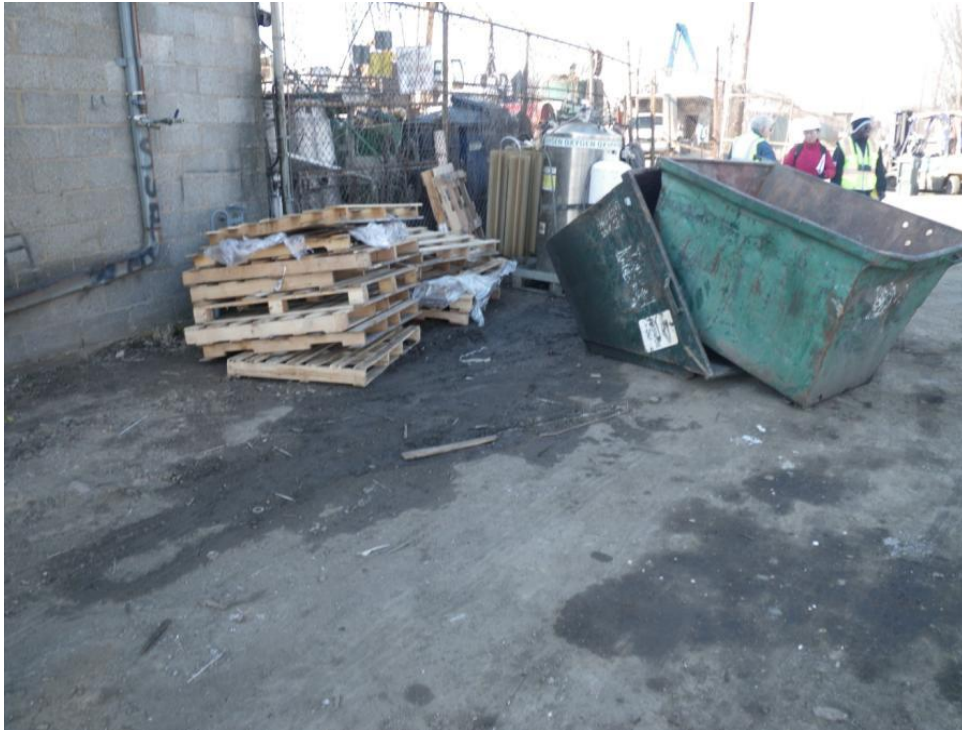
Photograph 75. **Staining on the ground outside of the perimeter fence near dumpsters.**

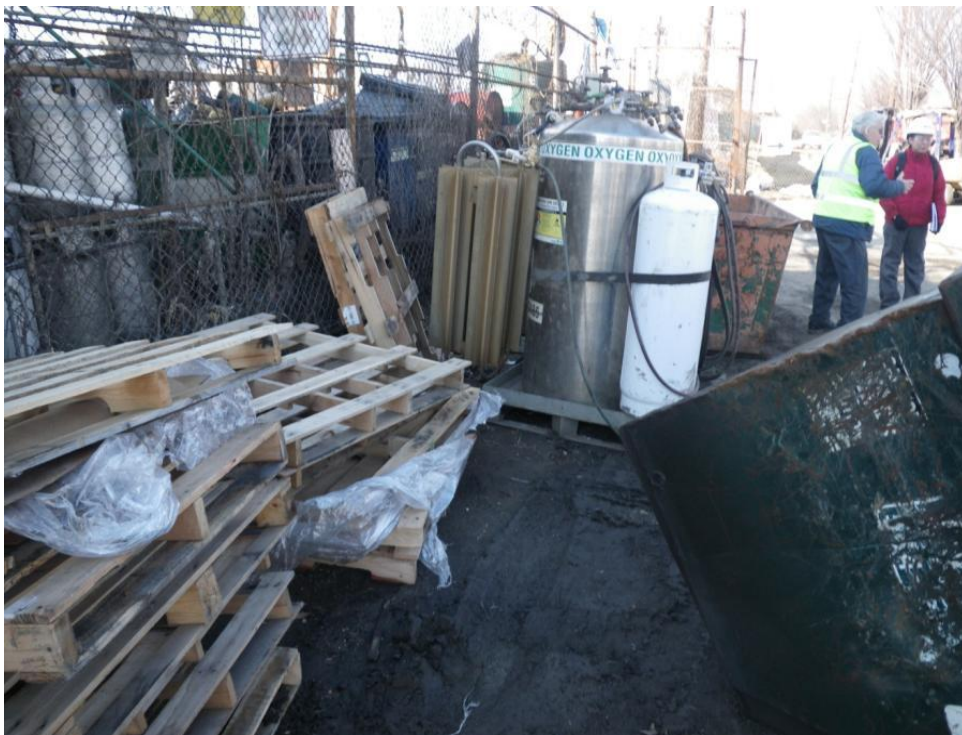
Photograph 76. **View of items stored the outside of the perimeter fence.**

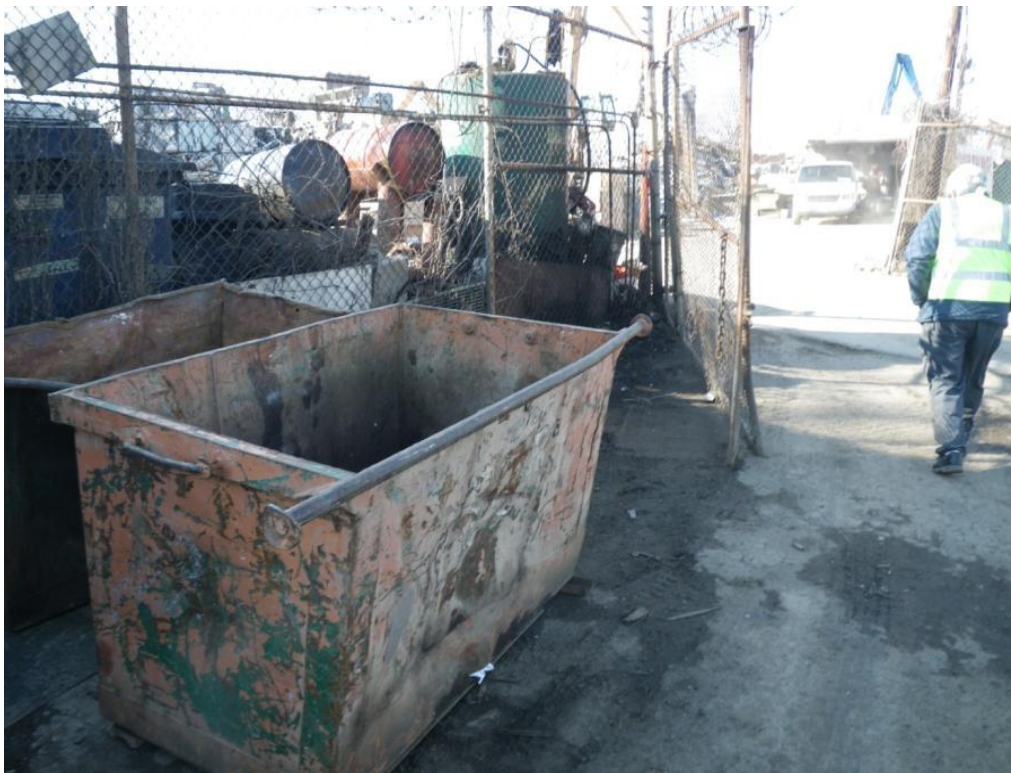
Photograph 78. **Staining and old dumpsters near Entrance 1.**

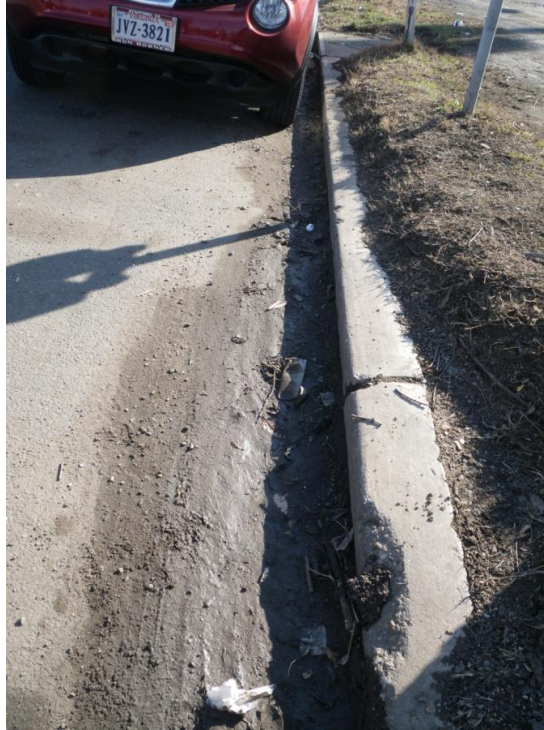
Photograph 79. Path of sediment leading from Super Salvage towards the storm drain.
Storm drain is located near the corner of First Street SW and S Street SW.

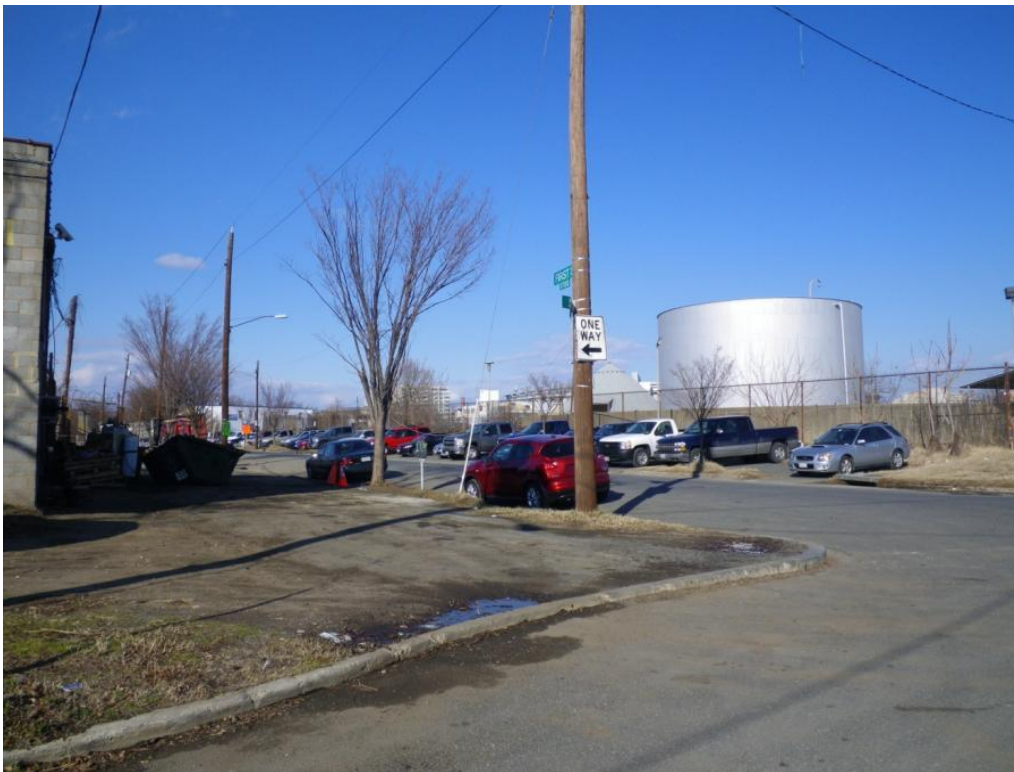
Photograph 82. Staining at the intersection of First Street SW and S Street SW.

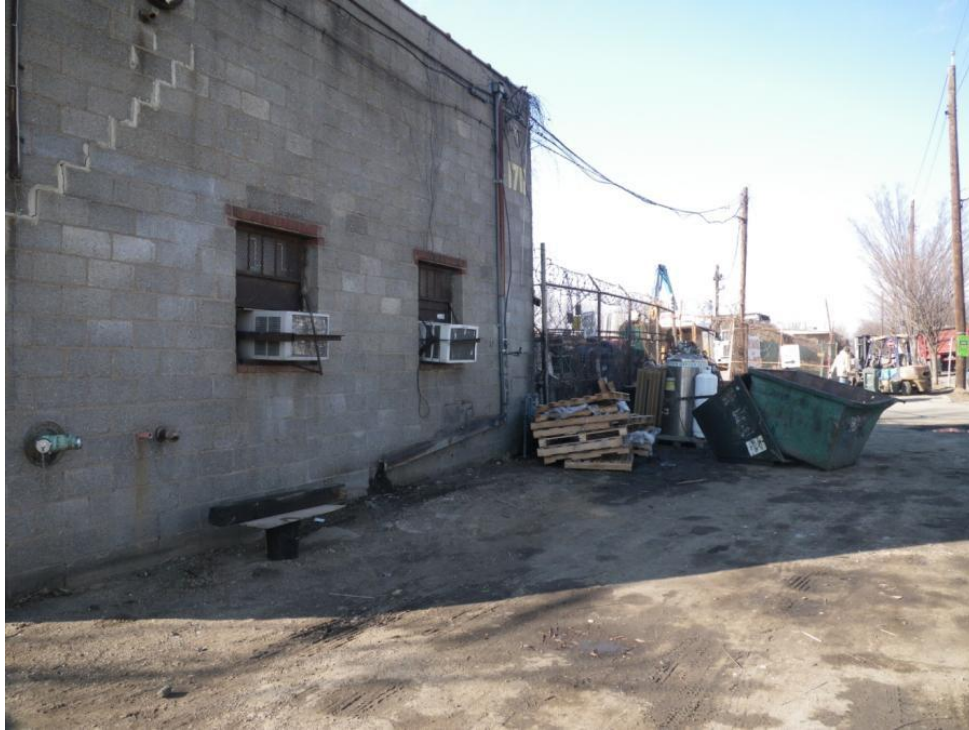
Photograph 83. View of the gutters and roof drains and the stained exterior of the facility near the corner of First Street SW and S Street SW.

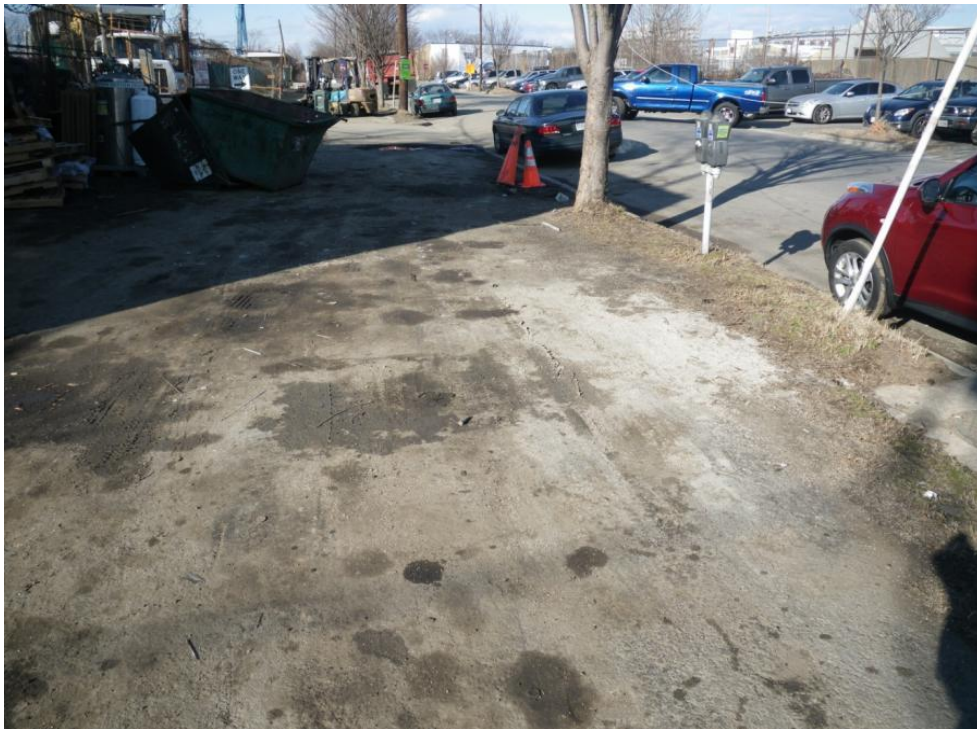
Photograph 84. Stains on the sidewalk adjacent to the site near the corner of First Street SW and S Street SW.
